Georgia Shore Stormwater and Shoreline Erosion Assessment

Final Report

August 2, 2021

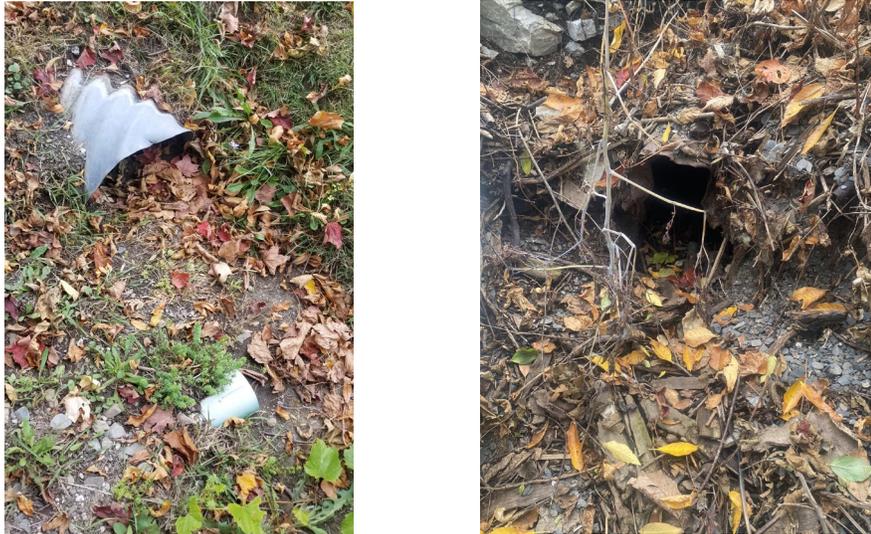
Figure 6. Culvert in need of maintenance (left). Erosion noted around culvert (right).

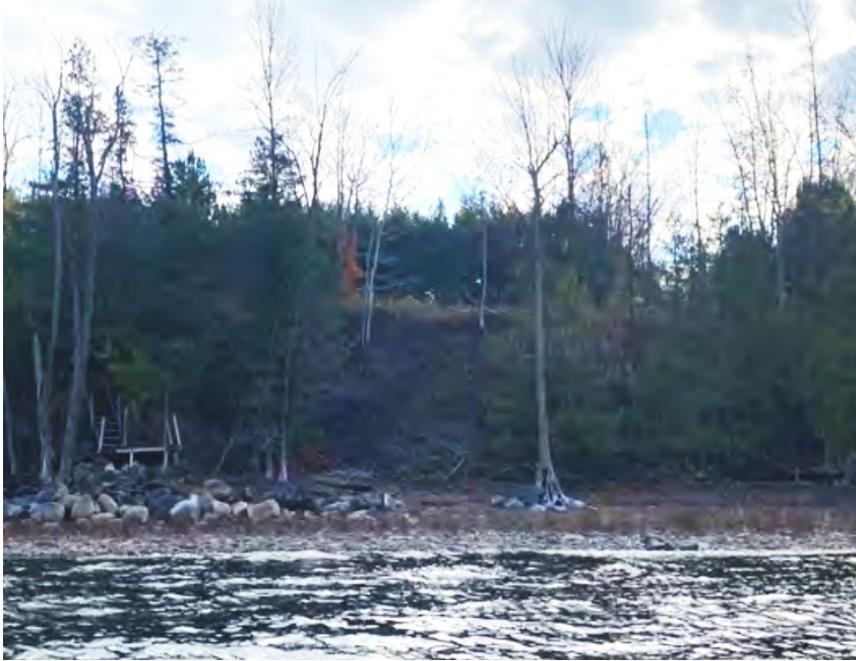
Issues observed during shoreline assessments included development (both roads and structures) very close to the shoreline, preventing establishment of a vegetated buffer and clearing

Figure 8. An example of erosion observed during shoreline assessments.

of vegetation up to the shoreline, which often resulted in erosion (Figure 8). These activities were often made more impactful due to the steep slopes present in several areas along the shoreline.

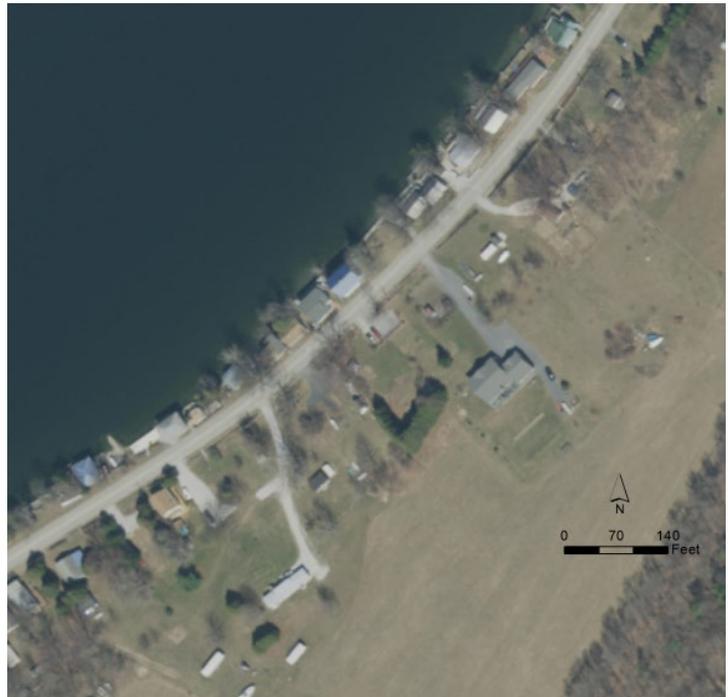
Figure 9. The residential development along Lake Champlain leaves little room for stormwater management practices in this area.

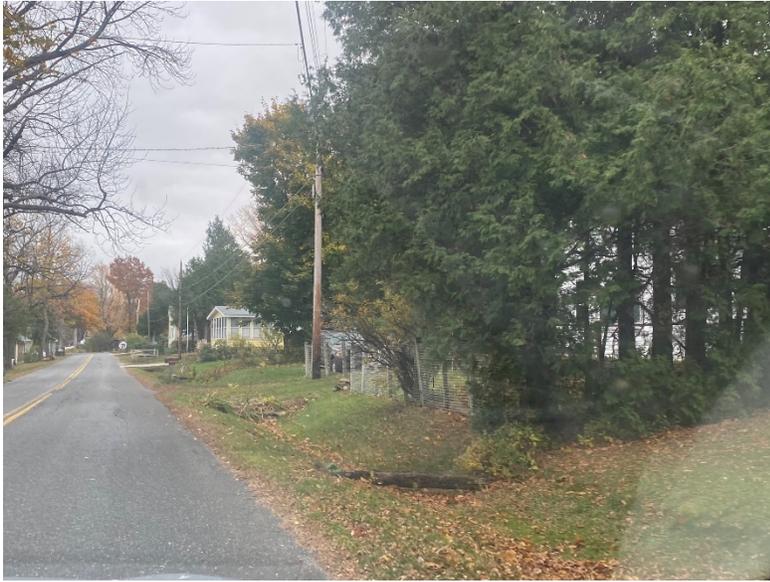
Figure 10. There are a series of grassed swales along Georgia Shore Rd that could be utilized for stormwater management.

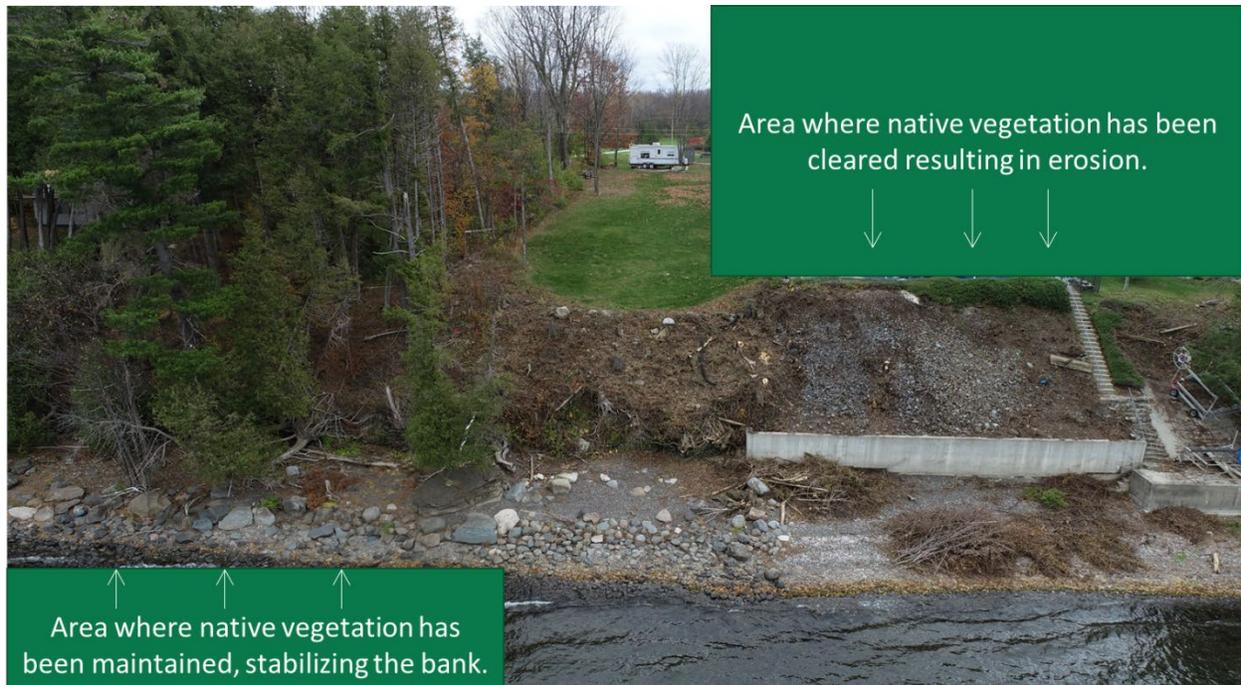
Figure 11. Abutting residential properties where vegetated buffers have been maintained (left) and removed (right) resulting in significantly different erosion rates.

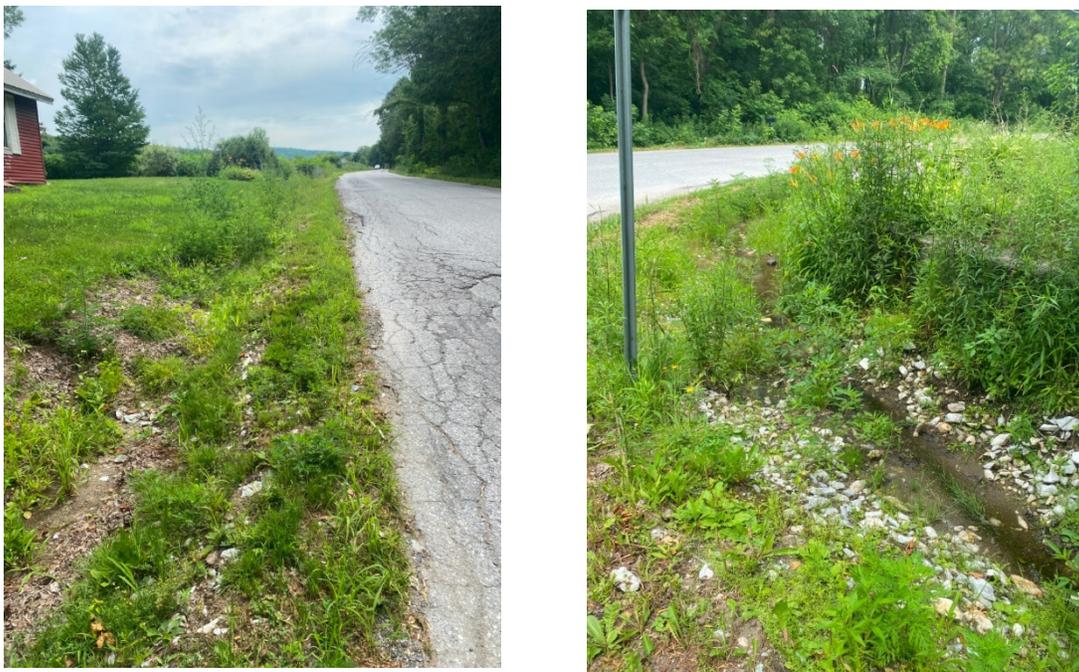
The intersection with Mill River Rd and Georgia Shore Rd has been identified by project stakeholders as a high priority area. See Figure 12 for photos of the area and Figure 13 for an overview map. Runoff along Mill River Road has damaged the infrastructure surrounding the road. Erosion has occurred and sediment is transported during rain events. The stormwater currently flows in a ditch along the northern side of Mill River Rd and drains west towards Georgia Shore Rd. The drainage then passes under Georgia Shore Rd in a culvert and drains toward Mill River. Mill River has been noted as a significant source of pollutants to the lake, and reducing stormwater impacts to Mill River is a priority.

Figure 12. Drainage runs west down Mill River Rd (left) to the intersection with Georgia Shore Rd (right) before passing under Georgia Shore Rd.

The proposed BMP includes reshaping the lower approximately 250ft of Mill River Rd to drain to the ditch on the north side of the road and allowing the water to flow in the existing culvert under Georgia Shore Rd. The water would then enter a plunge pool basin. The basin will slow down and spread the water out, allow for some minimal infiltration (infiltration is minimal as soils are not well drained in this area), and allow pollutants to settle out of suspension. The outlet will direct water into the wetland buffer north of the practice.

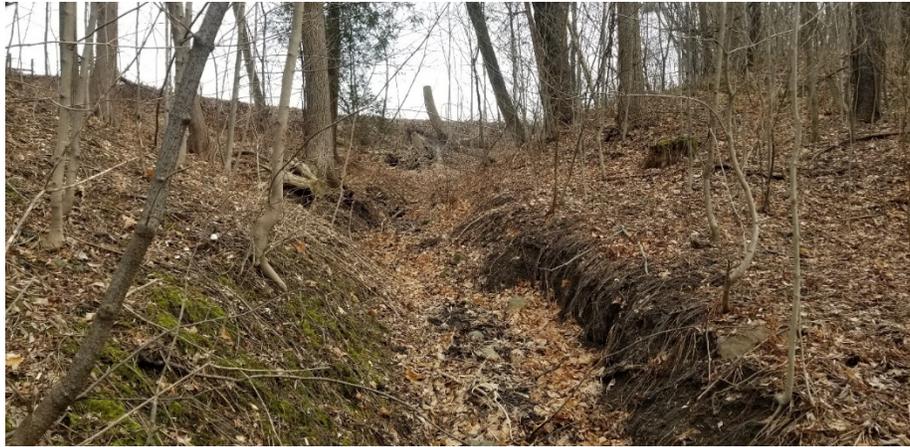
Runoff along Mill River Road has damaged the infrastructure surrounding the road. A gully has formed (Figure 14) just uphill of Mill River and sedimentation has increased into Mill River while uncontrolled runoff has changed the landscape in this area. The construction of several homes east of the intersection in recent years has increased stormwater volume by increasing impervious cover that prevents stormwater infiltration in this area.

Figure 14. An eroding gully has formed south of Mill River Road.

The proposed management of this area includes two BMPs that will reduce the volume of stormwater reaching the existing gully and stabilize the area to prevent future erosion. The first component of the project includes the installation of subsurface infiltration chambers within the Town right-of-way along Mill River Rd (see eastern starred location in Figure 15). The second component involves stabilizing the gully with stone and allowing for infiltration within the stabilized area (see western starred location in Figure 15).
