Georgia Shore Stormwater and Shoreline Erosion Assessment

Final Report

August 2, 2021

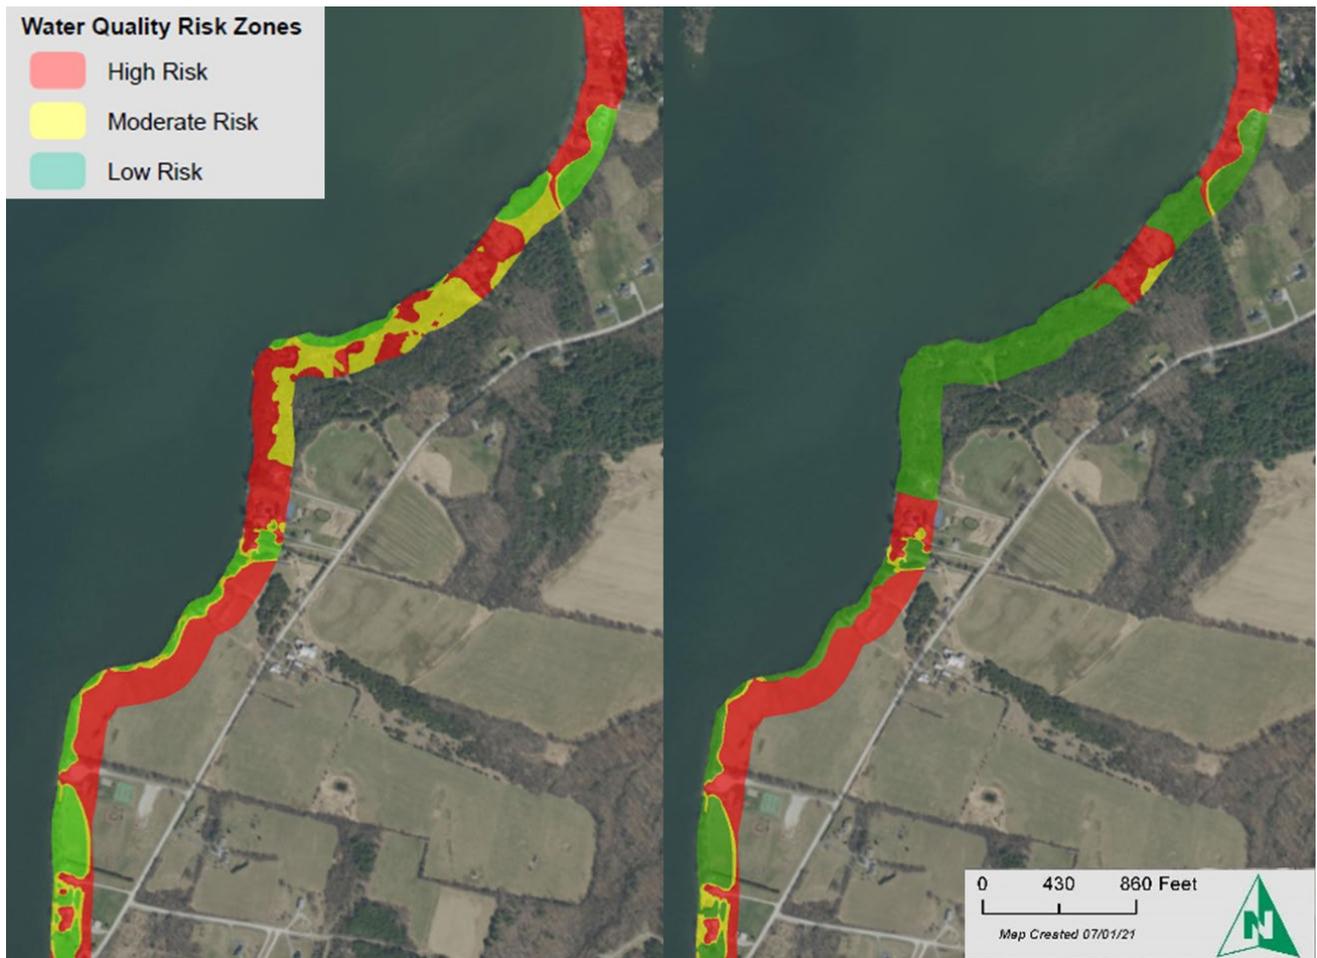
Figure 4. Water Quality Risk Zones were mapped (left), evaluated in the field, and manually corrected where necessary (right).

Note that in Figure 4, the original classifications were largely unchanged in the northern and southern sections of this area from the original (left) to the revised (right) Water Quality Risk Zones. However, the central area was reclassified from moderate and high risk to low risk as field verification revealed that while this area is very steep, it is controlled by bedrock and observed erosion was minimal. Both Water Quality Risk Zone datasets (pre and post field-based corrections) are included in Appendix F.

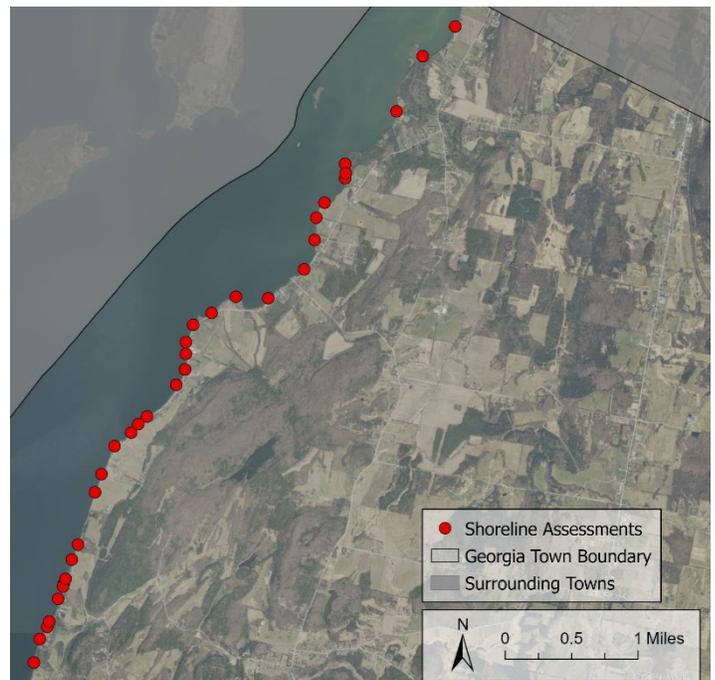
Issues observed during shoreline assessments included development (both roads and structures) very close to the shoreline, preventing establishment of a vegetated buffer and clearing

Figure 7. Shoreline assessment locations.

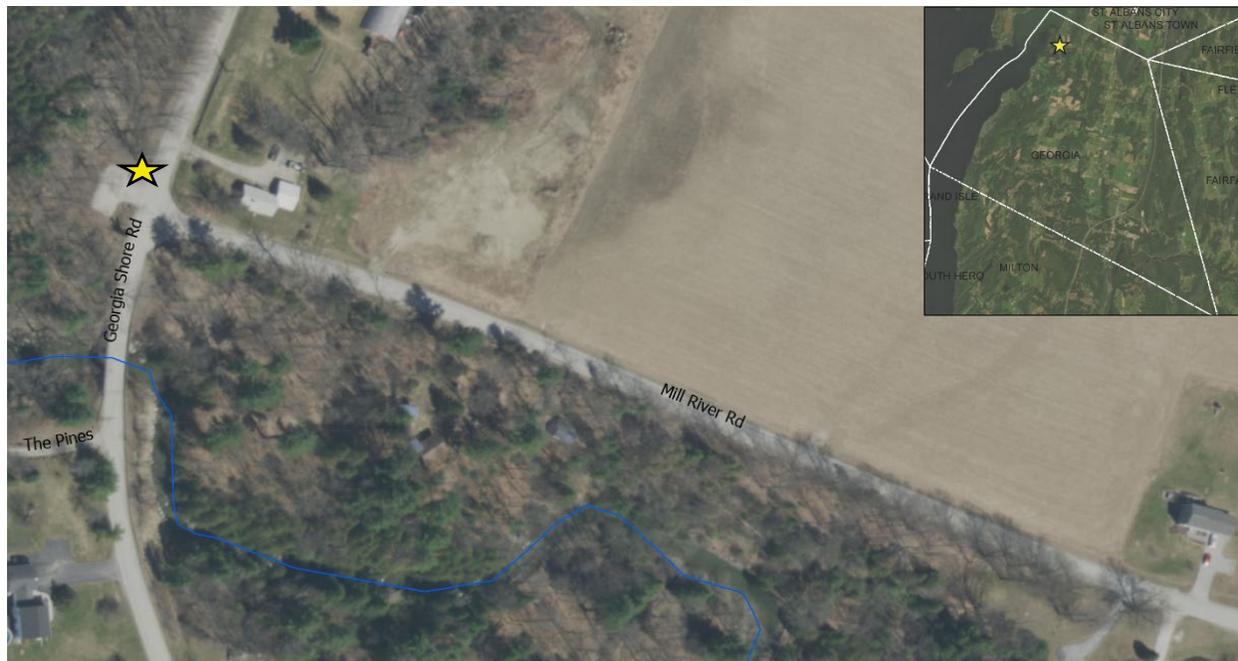
The intersection with Mill River Rd and Georgia Shore Rd has been identified by project stakeholders as a high priority area. See Figure 12 for photos of the area and Figure 13 for an overview map. Runoff along Mill River Road has damaged the infrastructure surrounding the road. Erosion has occurred and sediment is transported during rain events. The stormwater currently flows in a ditch along the northern side of Mill River Rd and drains west towards Georgia Shore Rd. The drainage then passes under Georgia Shore Rd in a culvert and drains toward Mill River. Mill River has been noted as a significant source of pollutants to the lake, and reducing stormwater impacts to Mill River is a priority.

Figure 13. The proposed practice is located in the northwest corner of the intersection of Georgia Shore Rd and Mill River Rd. See starred location.

There are potential modifications to the practice shape and location that should be finalized during the final design. For instance, to relocate the practice outside of the wetland buffer, the practice could be located south of the parking lot along Georgia Shore Rd. The culvert would need to be redirected to this

location. However, the practice would then discharge directly to the Mill River as opposed to the wetland buffer where flows can be better mitigated and velocities further reduced. The practice could also be located slightly closer to Georgia Shore Rd, but this would require a steepening of the road shoulder, which could be a hazard for vehicles, particularly in the winter. The 30% design can be found in Appendix E.

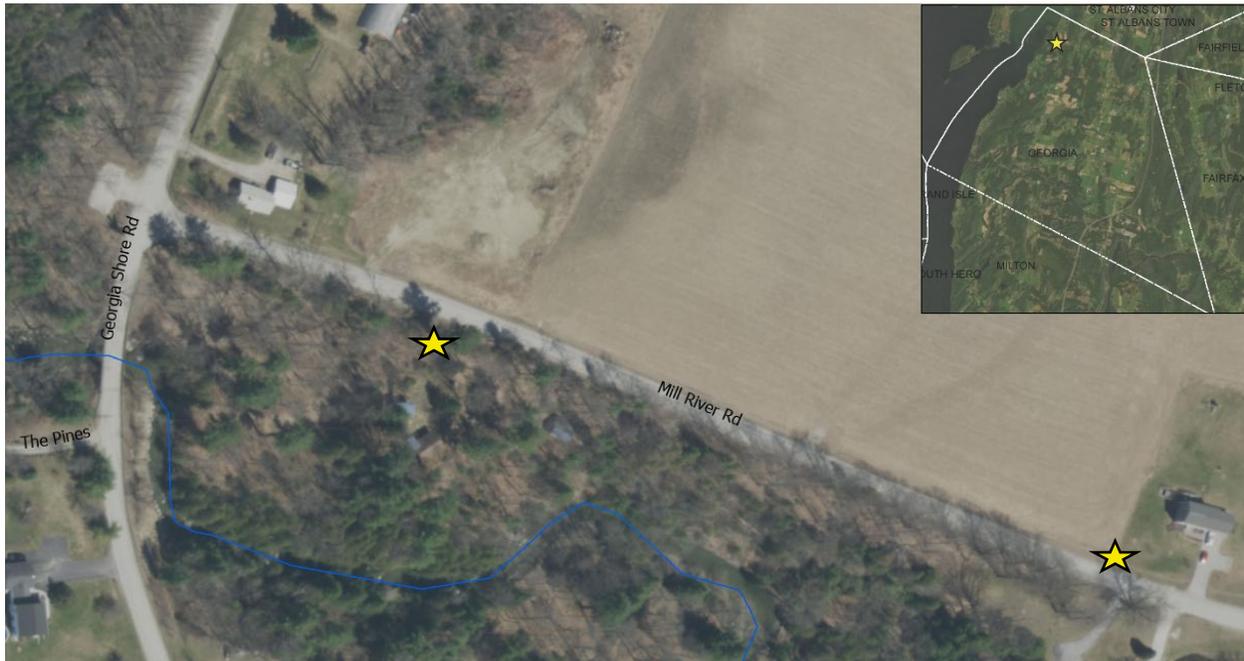
Runoff along Mill River Road has damaged the infrastructure surrounding the road. A gully has formed (Figure 14) just uphill of Mill River and sedimentation has increased into Mill River while uncontrolled runoff has changed the landscape in this area. The construction of several homes east of the intersection in recent years has increased stormwater volume by increasing impervious cover that prevents stormwater infiltration in this area.

Figure 15. The proposed practices are located along the southern side of Mill River Rd and to the northeast side of Mill River Rd. See starred locations.

The proposed management of this area includes two BMPs that will reduce the volume of stormwater reaching the existing gully and stabilize the area to prevent future erosion. The first component of the project includes the installation of subsurface infiltration chambers within the Town right-of-way along Mill River Rd (see eastern starred location in Figure 15). The second component involves stabilizing the gully with stone and allowing for infiltration within the stabilized area (see western starred location in Figure 15).

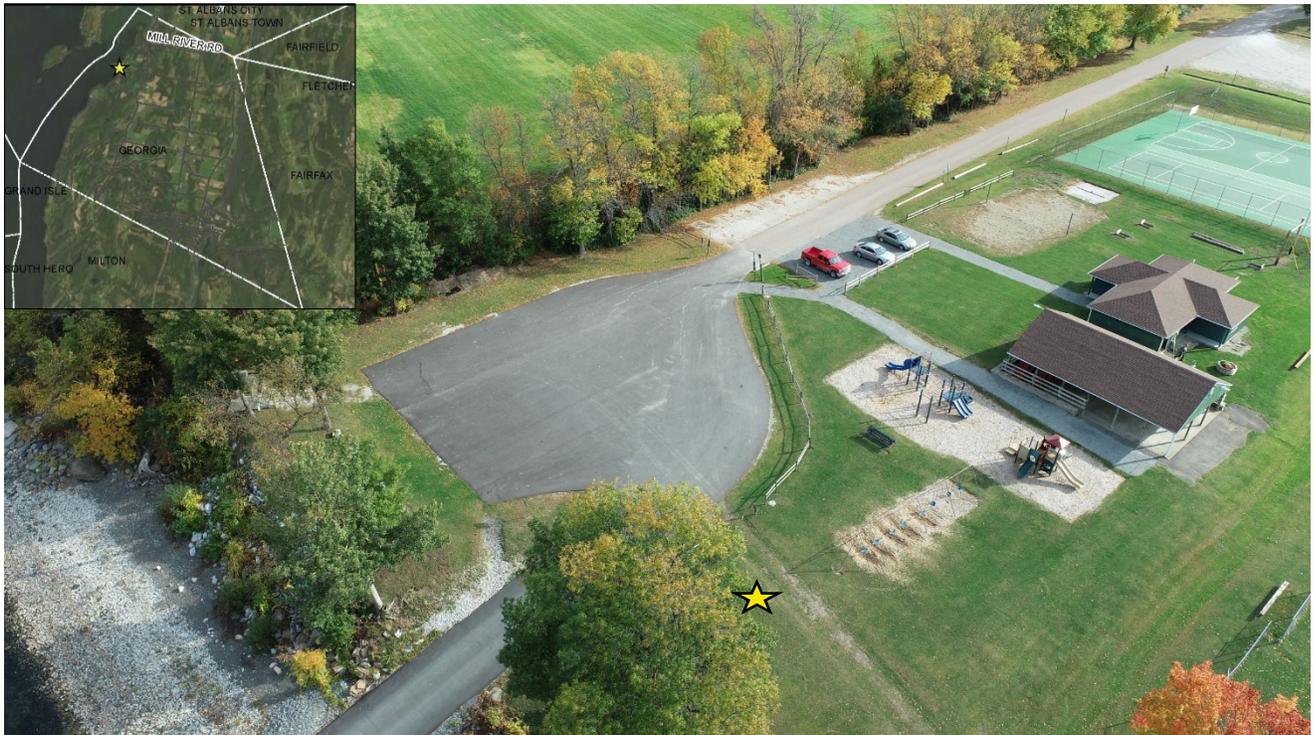
A bioretention practice has been designed for the Georgia Town Beach (Figure 16). This site was deemed important due to its education and outreach potential, significant amount of impervious cover, and location adjacent to Lake Champlain. This area includes a boat launch area, ball fields, tennis courts, and a playground. The facility's pavilion can also be rented for events. Many residents and visitors recreate in this area. This BMP will be highly visible and should include educational signage when implemented. The bioretention can be designed with plants that are also aesthetically pleasing and can serve an example for other private landowners to see the type of practices that are possible for their properties. The sign can provide information about BMP functionality, design, and the benefits that will be vital for this area. This will help to get landowners 'on-board' with stormwater practices that will mitigate stormwater issues on their property as well as contributing to the overall runoff and erosion issues along the Georgia Shoreline. As this area is dominated by individual residential development, adoption of stormwater best practices by these residential sites will be critical. This is unlike areas that are dominated by large parcels with many acres of impervious cover that could be managed in one large practice.

Figure 16. A bioretention practice is proposed in the starred location at the Georgia Town Beach.
